**Flood Control Project Maintenance
Levee Inspections**

Maintenance Issue Types Only, Levee Inspection Report By Mile - Spring 2017

Plumas County

Waterway	Bank	Unit Miles	Inspection Start/End	Inspector
Unit No. 01 North Fork Feather River	Left	1.89	04/27/2017 04/27/2017	Bob Duffey

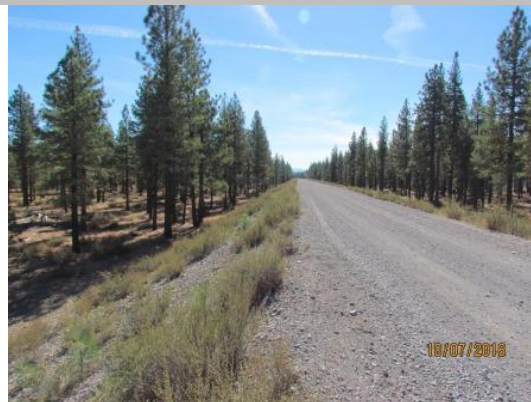
Photo 1 of 1 : SP_2017_NA0015_337_11_20170315_00008.jpg

LM Start	0.00	Rating **	M	Issue No.	11
LM End	1.89	Issue Type +	Ma	Location *	LS
Category	Earthen Levee			GPS Latitude/Longitude	
				Start	End
Item	Vegetation			40.273168 °	40.297283 °
				-121.244783 °	-121.257025 °
DWR ID	DWR_NA0015_01_f_2015_11				
Comment Code					
V2 : Remove the wild growth other than native grasses from the levee slopes.					
Inspector Comment					
Remove the small pine trees and other vegetation from the levee slope.

View of the small pine trees and other vegetation on the slope.

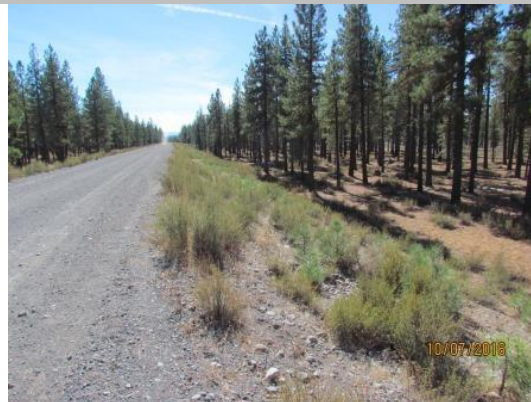
Photo 1 of 1 : SP_2017_NA0015_337_12_20170315_00009.jpg

LM Start	0.00	Rating **	M	Issue No.	12
LM End	1.89	Issue Type +	Ma	Location *	WS
Category	Earthen Levee			GPS Latitude/Longitude	
				Start	End
Item	Vegetation			40.273168 °	40.297283 °
				-121.244783 °	-121.257025 °
DWR ID	DWR_NA0015_01_f_2015_12				
Comment Code					
V2 : Remove the wild growth other than native grasses from the levee slopes.					
Inspector Comment					
Remove all small pine trees and other vegetation from the levee slope.

View of the small pine trees and other vegetation on the slope.

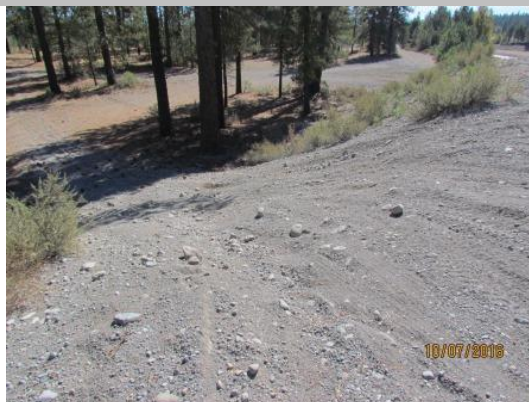
Photo 1 of 1 : SP_2017_NA0015_337_15_20170315_00011.jpg

LM Start	0.01	Rating **	M	Issue No.	15
LM End	0.01	Issue Type +	Ma	Location *	LS
Category	Earthen Levee			GPS Latitude/Longitude	
				Start	End
Item	Slope Stability			40.273274 °	40.273274 °
				-121.244779 °	-121.244779 °
DWR ID	DWR_NA0015_01_f_2016_15				
Comment Code					
S3 : Repair the levee slope damaged by vehicle traffic and prevent access where possible.					
Inspector Comment

View of the damaged slope by vehicle traffic.

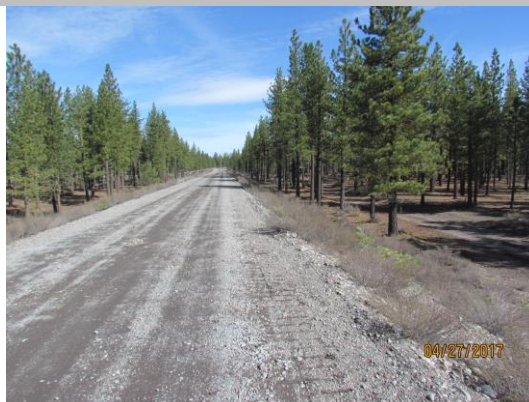
Photo 1 of 1 : SP_2017_NA0015_337_14_20170505_00015.jpg

LM Start	0.12	Rating **	M	Issue No.	14
LM End	0.12	Issue Type +	Ma	Location *	LS
Category	Earthen Levee			GPS Latitude/Longitude	
				Start	End
Item	Vegetation			40.274660 °	40.274660 °
				-121.245638 °	-121.245638 °
DWR ID	DWR_NA0015_01_s_2017_14				
Comment Code					
V2 : Remove the wild growth other than native grasses from the levee slopes.					
Inspector Comment					
Remove the small pine trees from the landside slope.

View of the small pine trees along the landside slope.

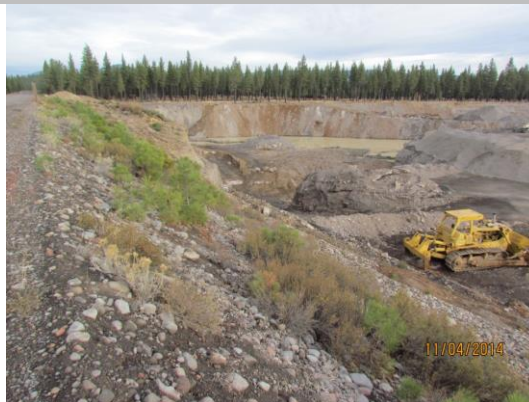
Photo 1 of 2 : SP_2017_NA0015_337_7_20170315_00004.jpg

LM Start	1.41	Rating **	U	Issue No.	7
LM End	1.50	Issue Type +	Ma	Location *	LS
Category	Earthen Levee			GPS Latitude/Longitude	
				Start	End
Item	Slope Stability			40.290758 °	40.291987 °
				-121.255402 °	-121.256072 °
DWR ID	DWR_NA0015_01_f_2014_7				
Comment Code					
S1 : Repair slope instability.					
Inspector Comment					
The landowner needs to replace the material that has been removed from the toe of the levee.

View of the area where the contractor has removed the material from toe of the levee.

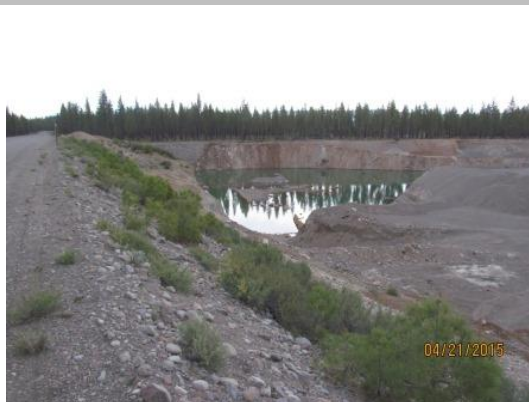
Photo 2 of 2 : SP_2017_NA0015_337_7_20170315_00005.jpg

LM Start	1.41	Rating **	U	Issue No.	7 (cont)
LM End	1.50	Issue Type +	Ma	Location *	LS

View of the area where the contractor has removed the material from toe of the levee.

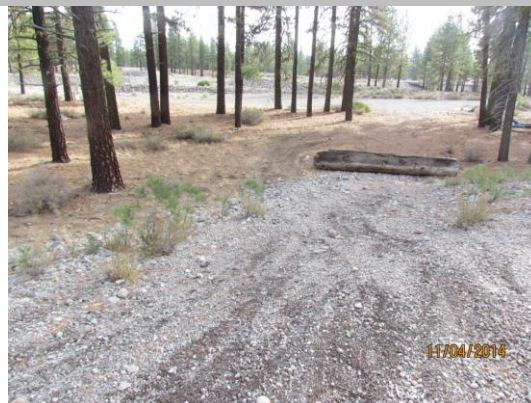
Photo 1 of 2 : SP_2017_NA0015_338_6_20170315_00005.jpg

LM Start	0.46	Rating **	M	Issue No.	6
LM End	0.46	Issue Type +	Ma	Location *	WS
Category	Earthen Levee			GPS Latitude/Longitude	
				Start	End
Item	Slope Stability			40.283059 °	40.283059 °
				-121.253989 °	-121.253989 °
DWR ID	DWR_NA0015_02_f_2013_6				
Comment Code					
S3 : Repair the levee slope damaged by vehicle traffic and prevent access where possible.					
Inspector Comment

View of the vehicle erosion on the landside slope.

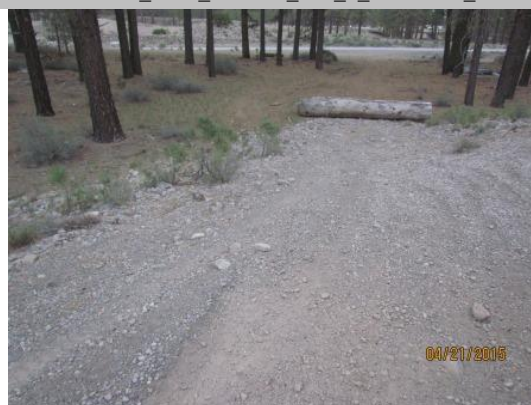
Photo 2 of 2 : SP_2017_NA0015_338_6_20170315_00006.jpg

LM Start	0.46	Rating **	M	Issue No.	6 (cont)
LM End	0.46	Issue Type +	Ma	Location *	WS

View of the vehicle erosion on the waterside slope.

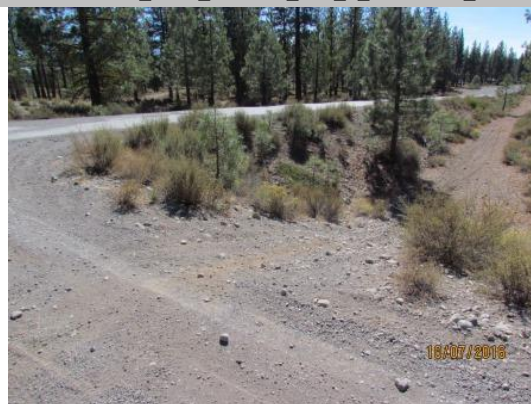
Photo 1 of 1 : SP_2017_NA0015_338_4_20170315_00003.jpg

LM Start	0.55	Rating **	M	Issue No.	4
LM End	0.55	Issue Type +	Ma	Location *	LS
Category	Earthen Levee			GPS Latitude/Longitude	
				Start	End
Item	Slope Stability			40.281950 °	121.253710 °
				40.281950 °	121.253710 °
DWR ID	DWR_NA0015_02_s_2012_4				
Comment Code					
S3 : Repair the levee slope damaged by vehicle traffic and prevent access where possible.					
Inspector Comment

View of the slope instability cause by vehicle along the landside slope.

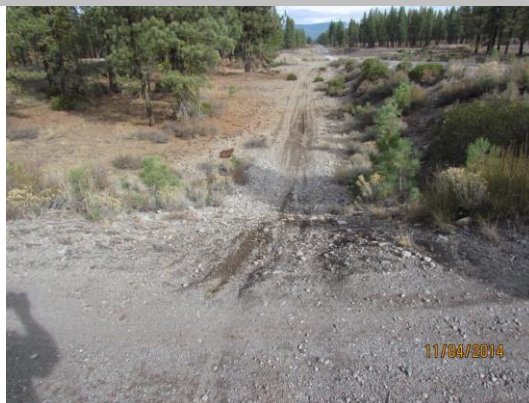
Photo 1 of 1 : SP_2017_NA0015_338_5_20170315_00004.jpg

LM Start	0.55	Rating **	M	Issue No.	5
LM End	0.55	Issue Type +	Ma	Location *	WS
Category	Earthen Levee			GPS Latitude/Longitude	
				Start	End
Item	Slope Stability			40.281950 °	121.253710 °
				40.281950 °	121.253710 °
DWR ID	DWR_NA0015_02_s_2012_5				
Comment Code					
S3 : Repair the levee slope damaged by vehicle traffic and prevent access where possible.					
Inspector Comment

View of the vehicle erosion on the waterside slope.

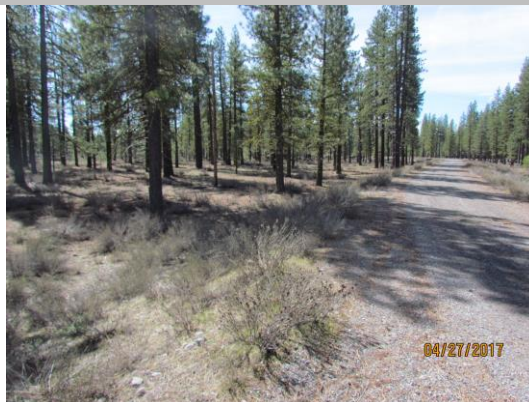
Photo 1 of 1 : SP_2017_NA0015_338_10_20170505_00013.jpg

LM Start	0.72	Rating **	M	Issue No.	10
LM End	1.36	Issue Type +	Ma	Location *	WS
Category	Earthen Levee			GPS Latitude/Longitude	
				Start	End
Item	Vegetation			40.279897 °	40.271772 °
				-121.252123 °	-121.246785 °
DWR ID	DWR_NA0015_02_s _ 2017_10				
Comment Code					
V2 : Remove the wild growth other than native grasses from the levee slopes.					
Inspector Comment					
Remove the vegetation from the waterside slope.

View of the vegetation along the water side slope.
